WEST BRANCH INSPECTIONS LLC

1234 Main St. Montoursville PA 17754

05/27/2021 9:00AM

InterNACHI Certified Professional Inspector

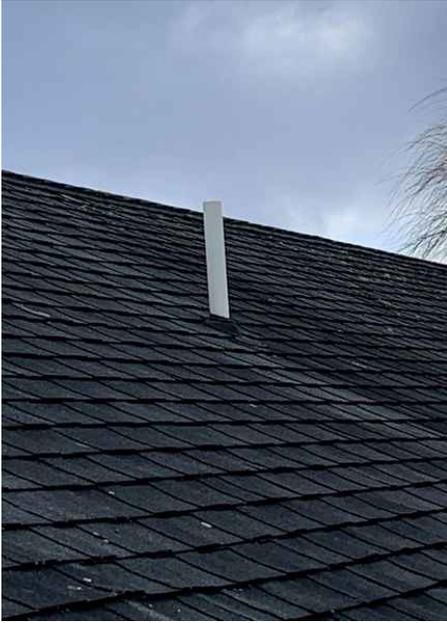
**Vent Stacks: Inspected**

I looked at DWV (drain, waste and vent) pipes that pass through the roof covering. There should be watertight flashing (often black rubber material) installed around the vent pipes. These plumbing vent pipes should extend far enough above the roof surface.

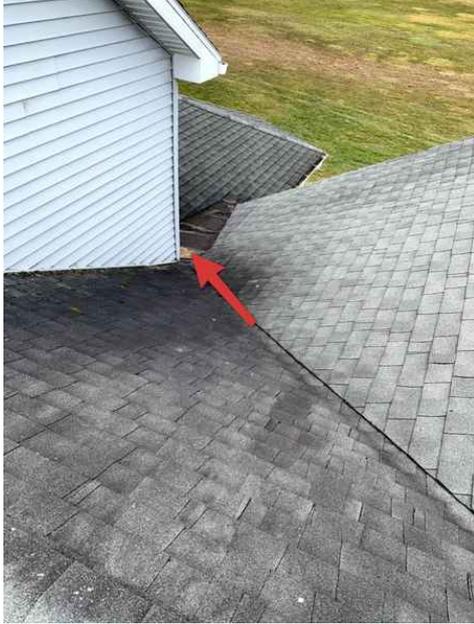
I observed an area where the roof is actively leaking. Active roof leaks should have immediate attention. Corrections and further evaluation by a qualified roof contractor is needed.

Water running down this valley, active leaks during rain and snowmelt

Contact a qualified roofing professional.

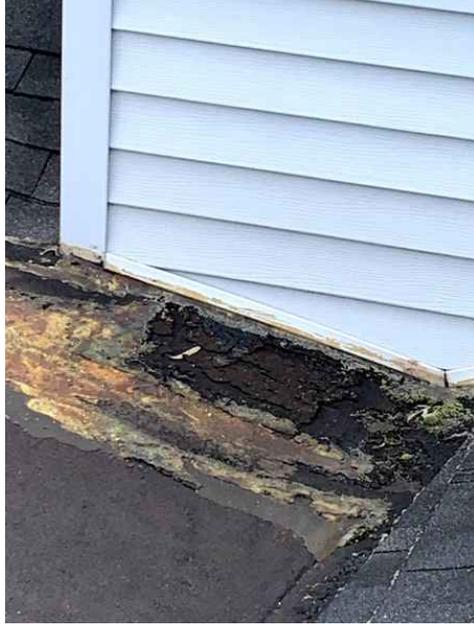
Rear garage-sunroom valley flashing in need of replacement

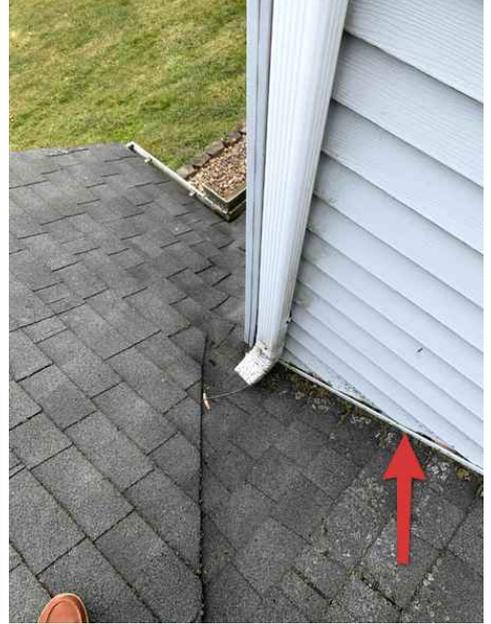
Water stains in the garage below this area of sidewall flashing

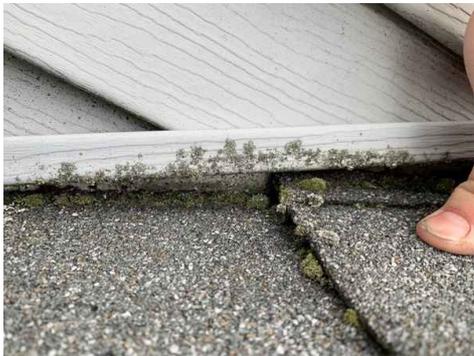
Metal flashing is present at sidewall. Unable to determine the cause of leak

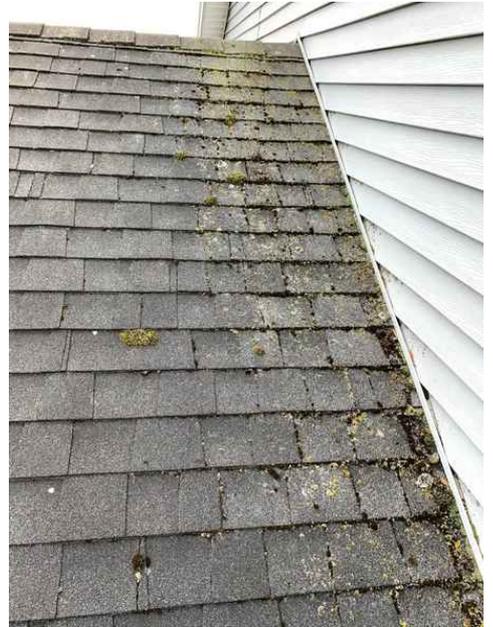
2.2.2 Roof Covering

The asphalt shingle roof had areas of moss growth. This condition indicates high moisture levels in areas of the roof that lack natural drying by sunlight. Moss growth may increase the chances of roof leakage by slowing drainage or reduce the wind resistance of the shingles through root tendrils invasion of sealant strips.

Contact a handyman or DIY project

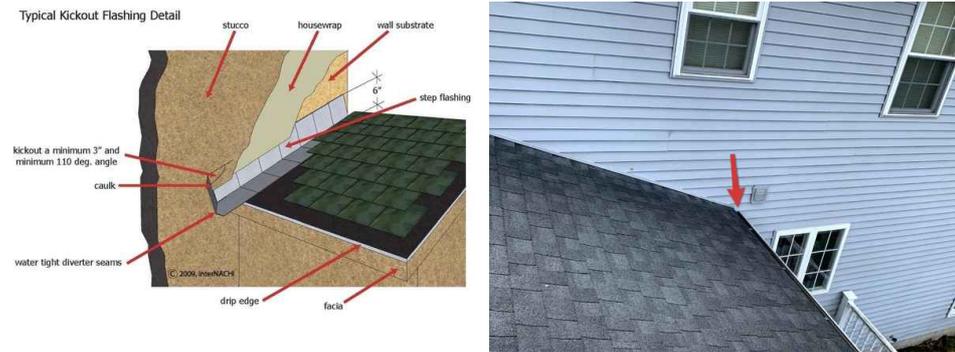
## 2.6.1 Exterior Flashings

**MISSING KICKOUT FLASHING**

I observed a missing kickout flashing. A kickout flashing should be installed anywhere a roof and exterior wall intersect, where the wall continues past the lower roof-edge and gutter. If a kickout flashing is absent in this location, large amounts of water may miss the gutter, penetrate the siding, and become trapped inside the wall. A kickout flashing "kicks" the roof water away from the house structure and diverts it into a gutter.

I recommend installation of a kickout flashing by a qualified roof contractor.

Contact a qualified roofing professional.

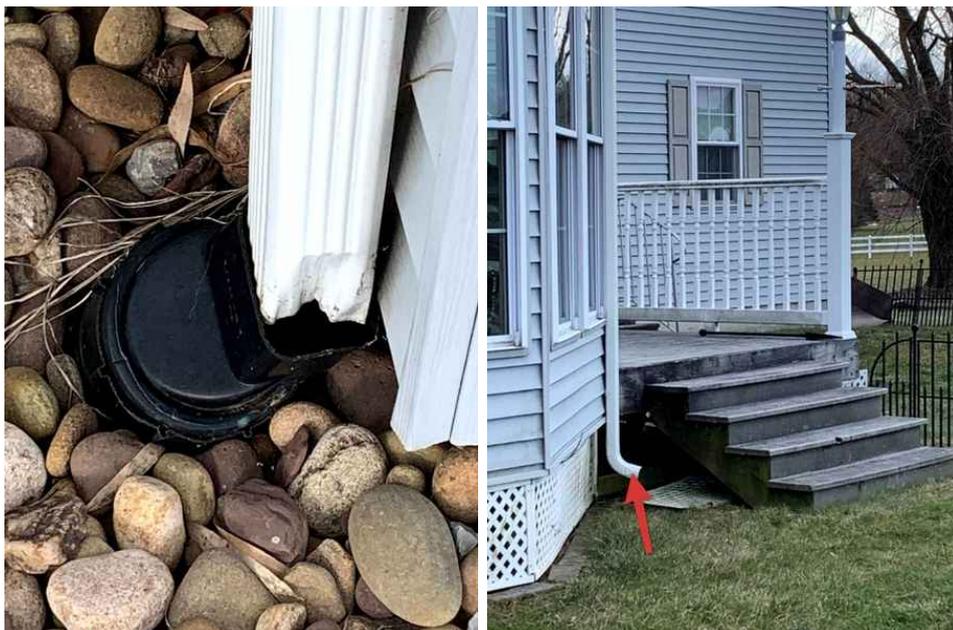
Left-Right Corner

One or more downspouts drain too close to the home's foundation. This can result in excessive moisture in the soil at the foundation. Recommend adjusting the downspout that appears to be offset leading to the underground extension.

Contact a handyman or DIY project

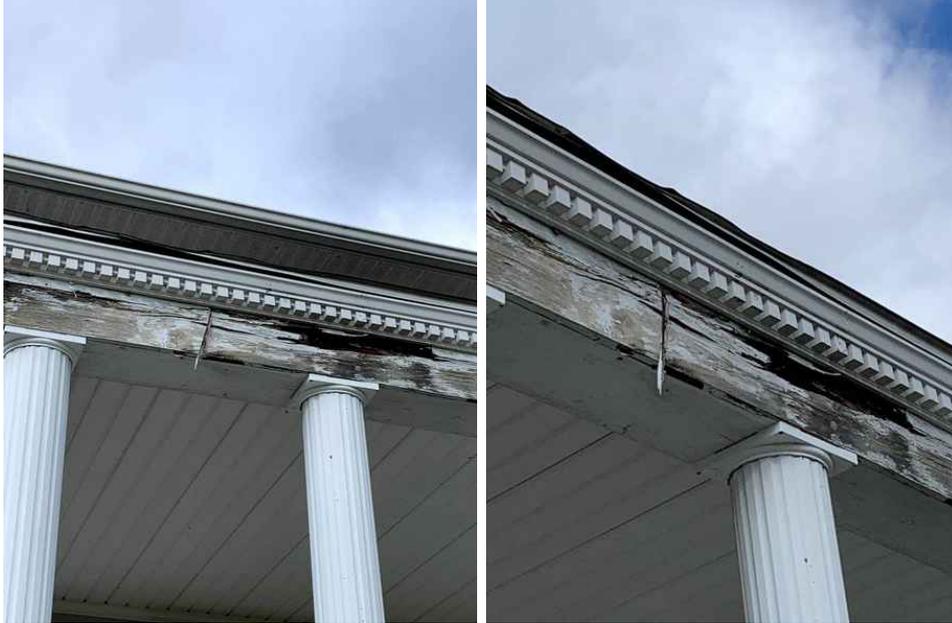
## 2.8.1 Soffit &amp; Fascia

**FASCIA-WOOD DECAY**

Wood rot is observed at areas of the wooden fascia. Recommend replacement of the damaged wood, and further analysis of the flashings at this area to repair the water penetration issue.

Contact a qualified general contractor.

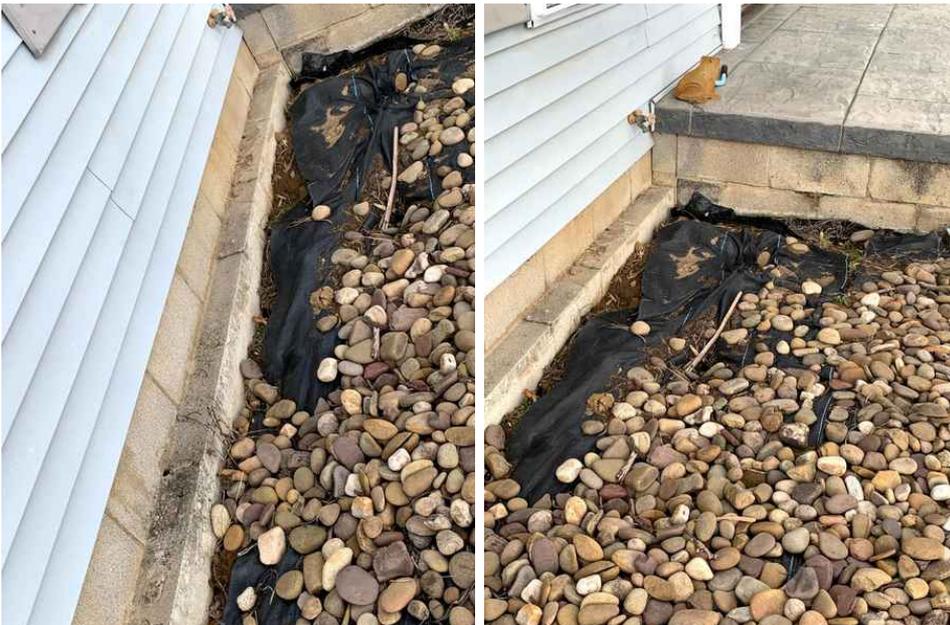
### NEGATIVE GRADING - IMPROPERLY SLOPED

Grading is sloping towards the home in some areas. This could lead to water intrusion and foundation issues.

The grading around a house should slope away from all sides, ideally 6 inches for the first 10 feet from the house foundation perimeter. Downspouts, surface gutters and drains should also be directing water away from the foundation.

Improvement is recommended.

Contact a qualified landscaping contractor

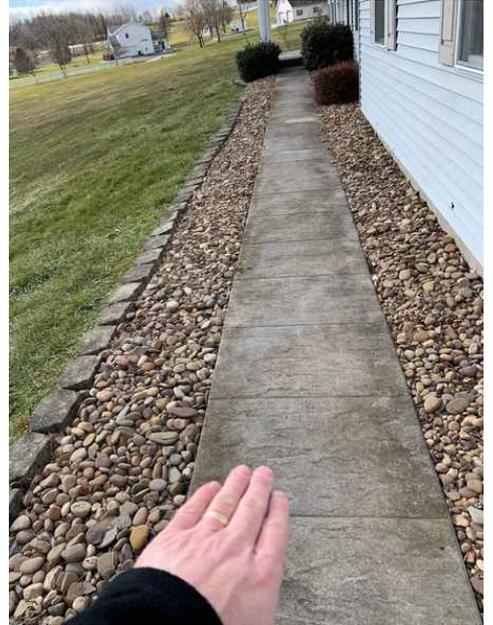
3.3.1 Driveways & Walkways

**WALKWAY SLOPING**

Walkway has settlement toward the foundation. The slabs may be able to be lifted to improve the sub-base of the walkway.

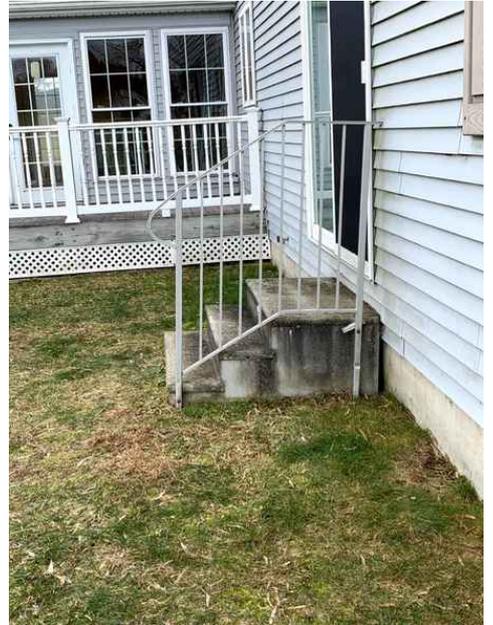
3.4.1 Stairs, Steps, Stoops, Stairways & Ramps

**STEPS MINOR SETTLEMENT**

The rear steps have settled slightly toward the foundation. Improvement and repairs recommended.

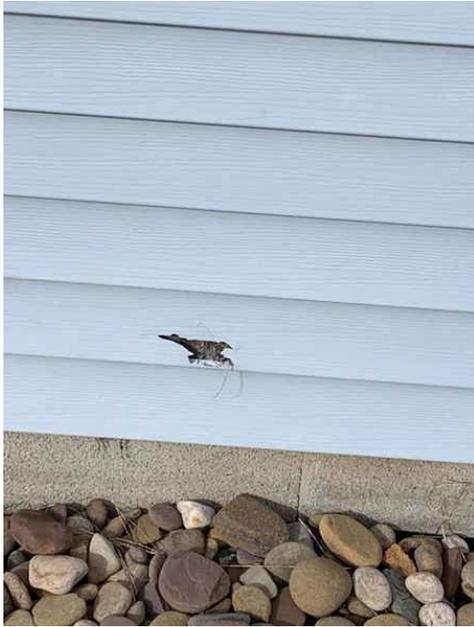
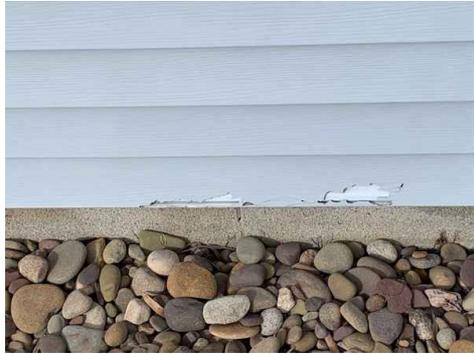
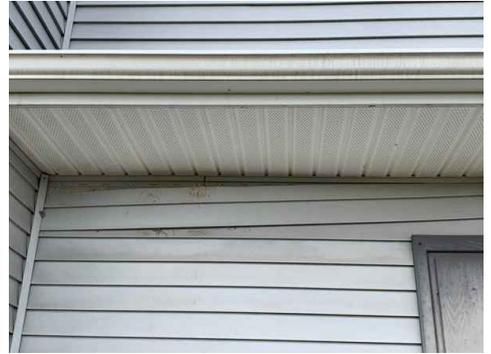
3.7.1 Wall-Covering, Flashing & Trim

**VINYL SIDING CRACKED/MISSING**

Siding showed cracking in several places. Portions of the siding are in need of repairs and sealing to prevent moisture penetration to the wall building materials. Recommend repairs and replacement to prevent moisture damage to the wooden components of the exterior walls.

Contact a handyman or DIY project

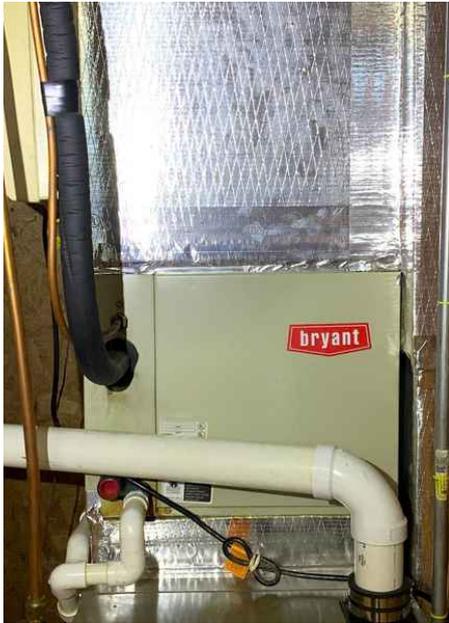
### Evaporator Coil: A/C Evaporator Coil

The air conditioning system was a split system in which the cabinet housing the compressor, cooling fan and condensing coils was located physically apart from the evaporator coils. As is typical with split systems, the compressor/condenser cabinet was located at the home's exterior so that the heat collected inside the home could be released to the outside air. Evaporator coils designed to collect heat from the home interior were located inside a duct at the furnace and were not directly visible.

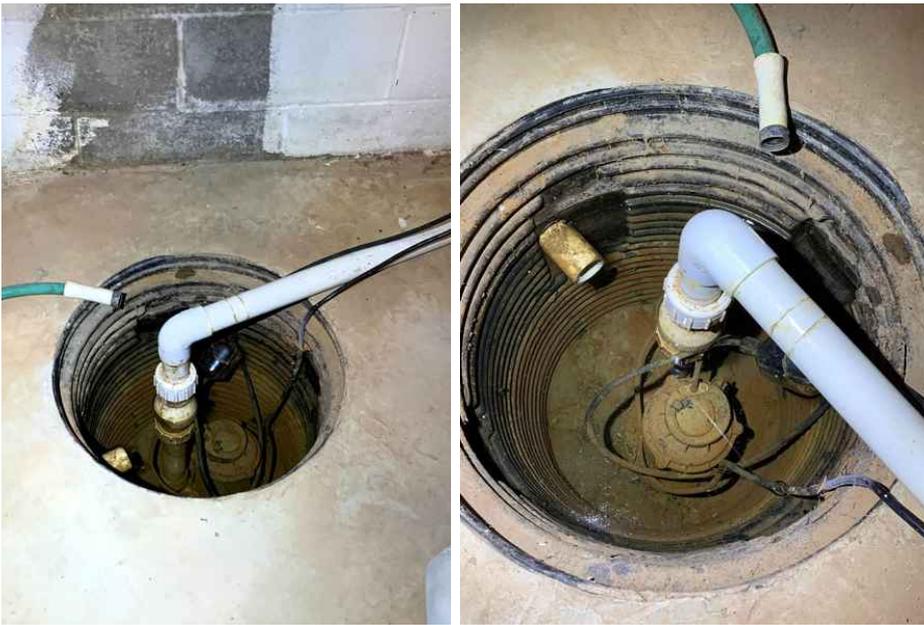
### Sump Pump: Water in Sump Pump

I observed standing water in the sump pump bucket. This indicates that the sump pump is critical and necessary to keep the house basement or foundation from having water intrusion problems developing. Monitoring and testing the pump regularly is recommended.

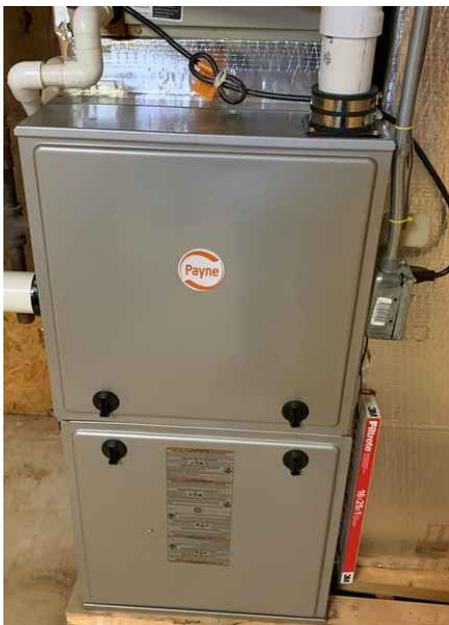
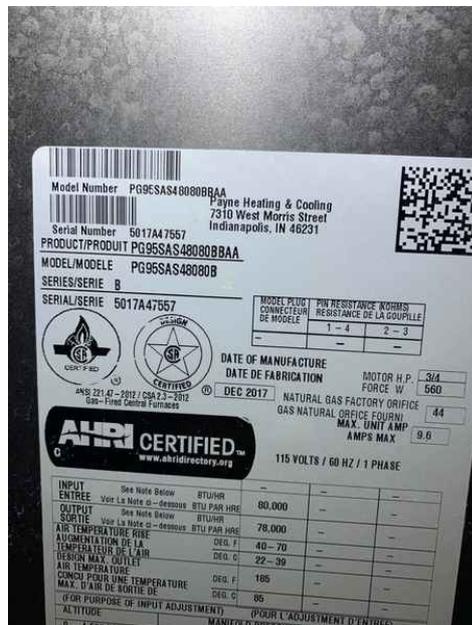
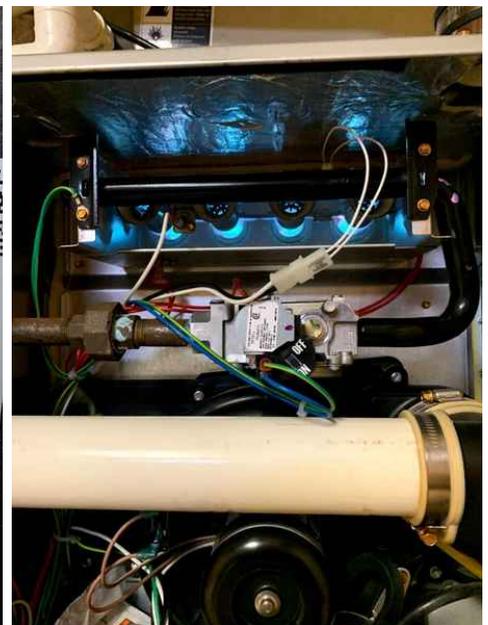
### HVAC Manufacturer: Brand

Payne

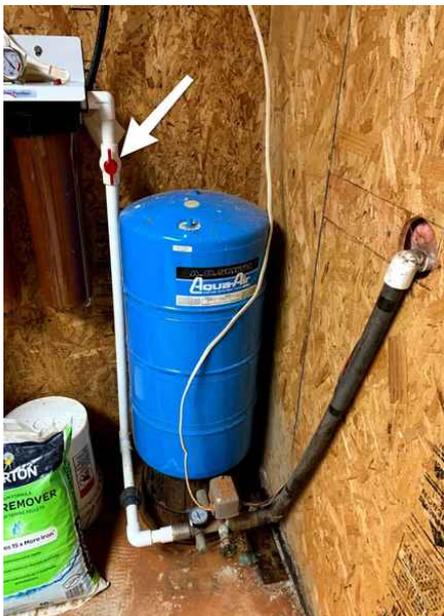
**Main Water Shut-Off Valve:**  
**Location of Main Shut-Off Valve**  
 At the well supply tank

**Hot Water Source: Age of the Water Heater**  
 2013

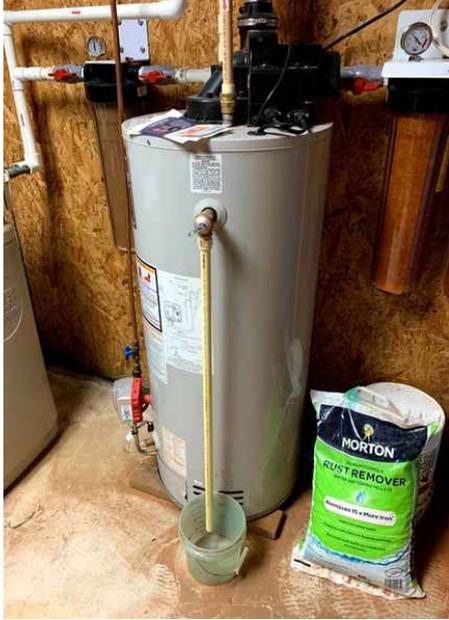
### Hot Water Source: Inspected TPR Valve

I inspected the temperature and pressure relief valve. A proper extension is installed.

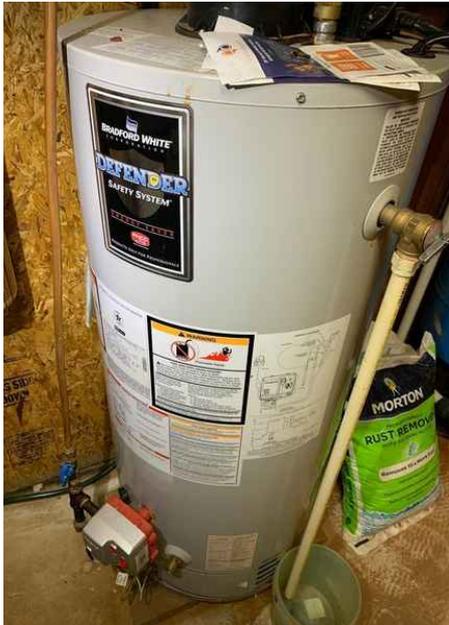
### Hot Water Source: Water Heater Manufacturer

Bradford White

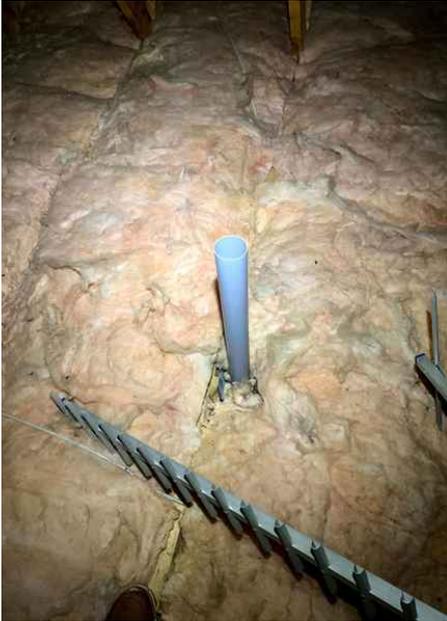
### Drain, Waste, & Vent Systems: Pipe Terminating in the Attic

There is a pipe that terminates in the attic. I can not fully determine what the pipe is used for. It may be a plumbing vent. If it is a plumbing vent, it will need to be terminated to the exterior to prevent sewer gas from entering the attic.

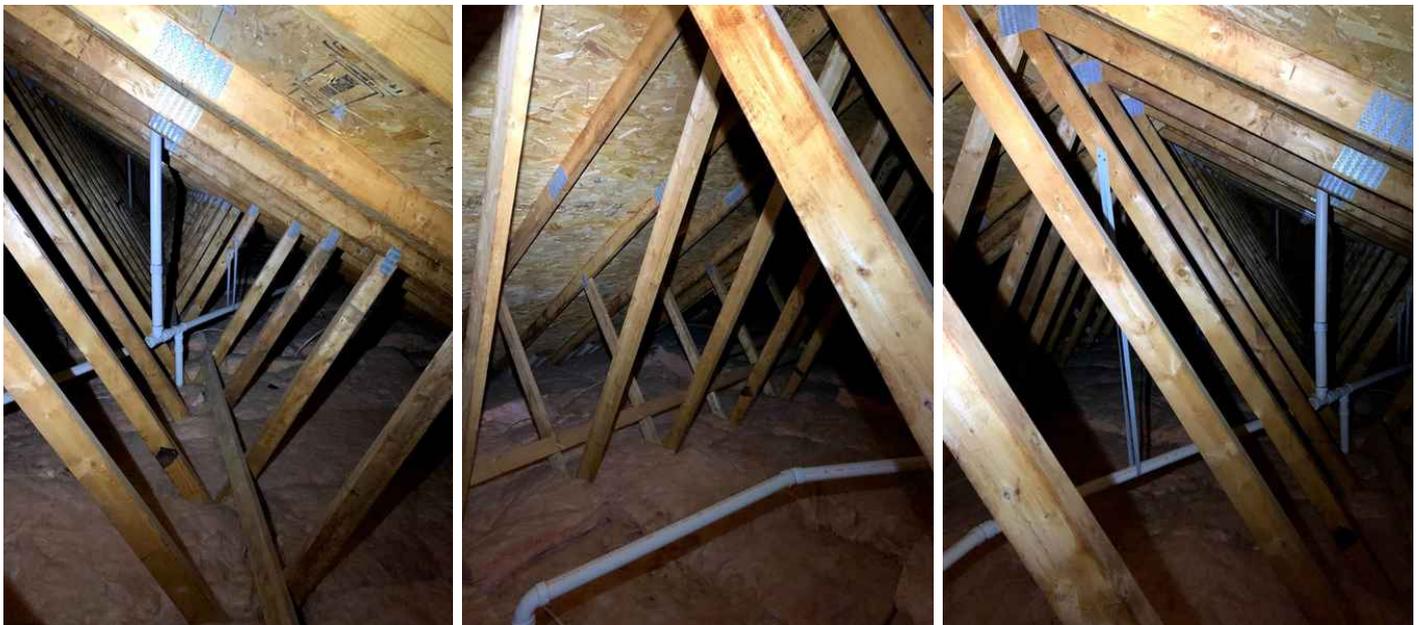
**Structural Components & Observations in Attic: Structural Components Were Inspected**

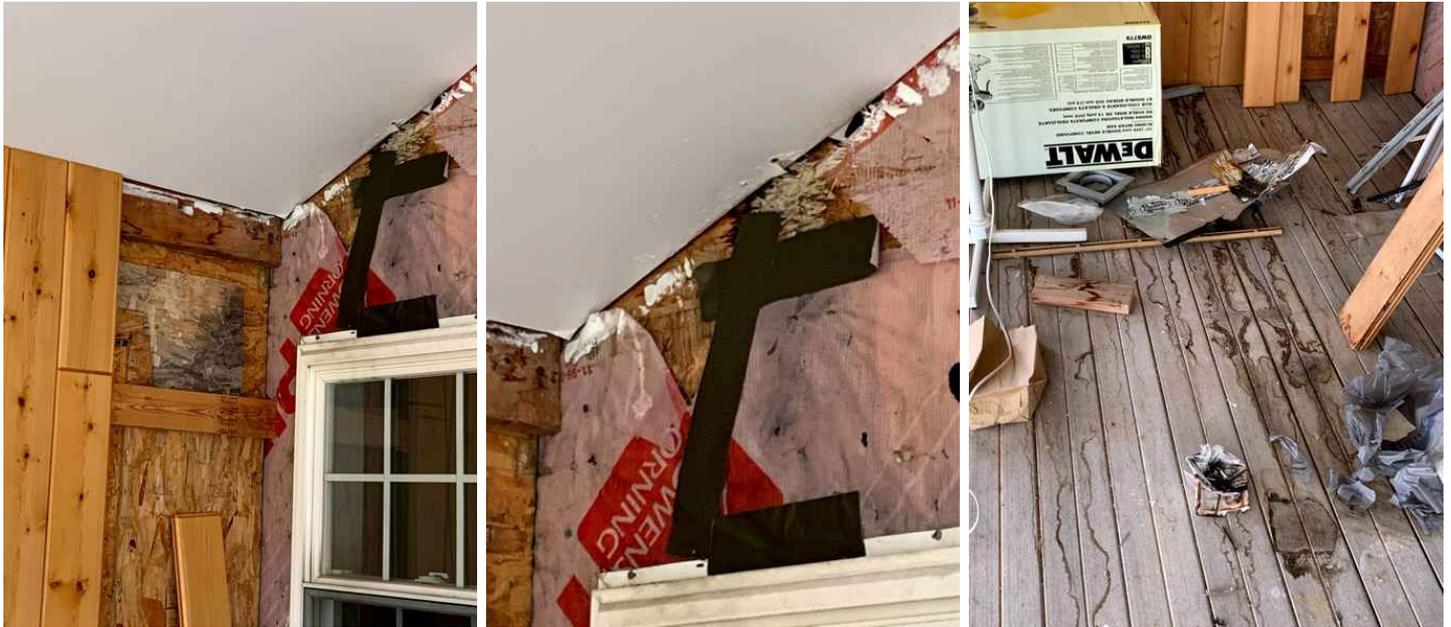
- 🔧 12.4.1 Doors, Windows & Interior - Floors, Walls, Ceilings: Moderate Wear
- ⚠ 12.4.2 Doors, Windows & Interior - Floors, Walls, Ceilings: Moisture Damage

Recommendation

Contact a qualified roofing professional.

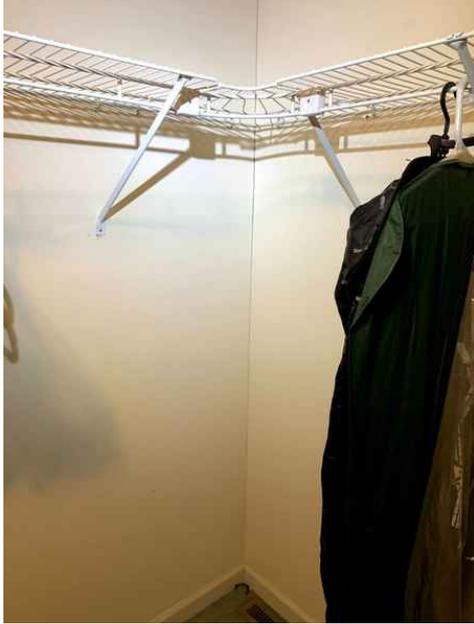
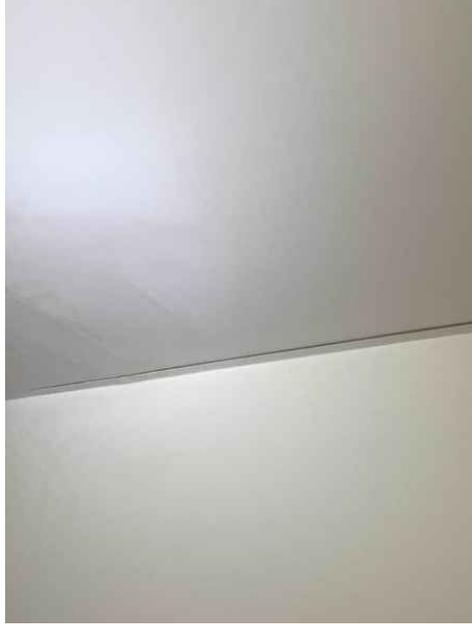
12.4.3 Floors, Walls, Ceilings

**MINOR DRYWALL CRACKS**

Recommendation

Contact a qualified drywall contractor.
